Assessment of Water Quality of Peddacheruvu, Sambaiah Cheruvu, Gaddapotharam and Rudraram Cheruvu of Medak District

Center for Environment, Institute of Science and Technology, Jawaharlal Nehru Technological University, Hyderabad, India 500 085

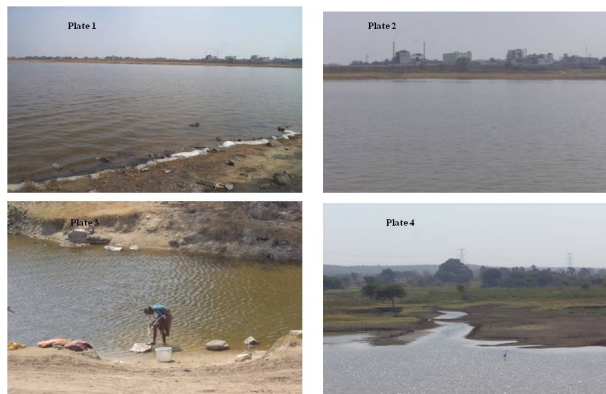
Fig. 1. Plate 1:Gaddapotharam Lake; Plate 2: Industries near Gaddapotharam Lake; Plate 3 Washing inlet to Peddacheruvu; Plate 4 Field inlet to Peddacheruvu

longitude in Medak district. The total area of the lake (Fig 1-Plate 1 & 2) is approximately 0.08 Km². The total catchment area of the Gaddapotharam village is 0.093 Km² (approximately). The main catchment – industrial area (with a total industrial area of 2.5 Km² approx.) is located towards the southeast side of the lake. The lake is fed by 2-3 minor channels or streams. Maximum depth of the lake is about 10 ft.

1.1.2 Pedda cheruvu: It is located at a latitude of 17°44' and 78°23' longitude with a total area of 0.077 Km² and a depth of 3ft approximately (Fig 1-Plate 3 & 4). Towards north of the lake is the Gomaram village with a total catchment area of 0.3 Km² approx. while agricultural fields occupying approximately 0.28 Km² of area exists towards the south of the lake. Industries are located towards the northeast of the lake.

The pH of the surface water of Peddacheruvu is within the permissible limits of US-EPA and WHO standards (6.0-8.5). The conductivity in all the samples is ranging from 874-911µS/cm except for the sample 2, which is collected from the inlet near field side (1550µS/cm) and sample 1 collected from washing inlet to cheruvu (1361µS/cm).

The concentration of phosphates ranged from 1.0-3.8 mg/l. Samples 1 & 2 collected from washing inlet to cheruvu and inlet at the field site showed high concentration of phosphates (3.8 & 3.5 mg/l) which might be due to the detergents used during washing at the washing inlet site and phosphate fertilizers added to the field inlet site [10].

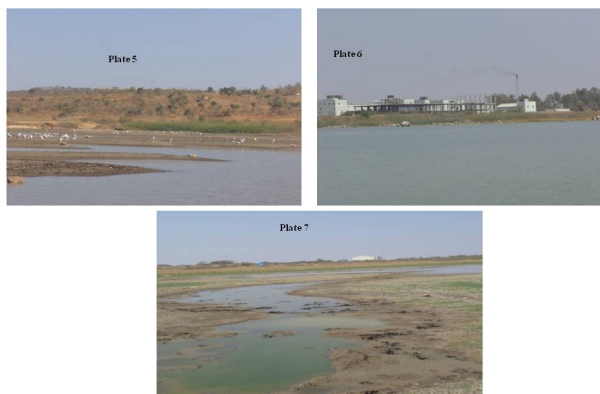
Fig. 2. Plate 5: Sambaiah Cheruvu with a number of birds; Plate 6:Industries at the North Eastern side of Rudraram cheruvu plate 7: Inlet at the South eastern side of Rudraram cheruvu with algae

1.1.3 Sambaiah cheruvu: It is located at a latitude of 17°43' and 78°23' longitude at an altitude of 2005 ft. The total area of the lake (Fig 2-Plate 5) approximates to almost 0.113 Km² and a depth of 3 ft. Towards northwest of the lake is the Nawabpet Village with a catchment area of approx. 0.163 Km². Industries are located towards south of the lake at an altitude of 2125 ft.

1.1.4 Rudraram cheruvu: It is located at a latitude of 17°33' and 78°10' longitude. The total area of the lake is approximately 0.24 Km². The depth of the lake (Fig 2-Plate 6 & 7) is about 5 ft approximately. Towards northwest of the
